Inspection Report

Facility: Venice Beach Apartments II

Venice Beach Apartments II, Venice, FL

Re: Inspection Report (3 of 6) for Venice Beach Apartments II performed 01/03/2024.

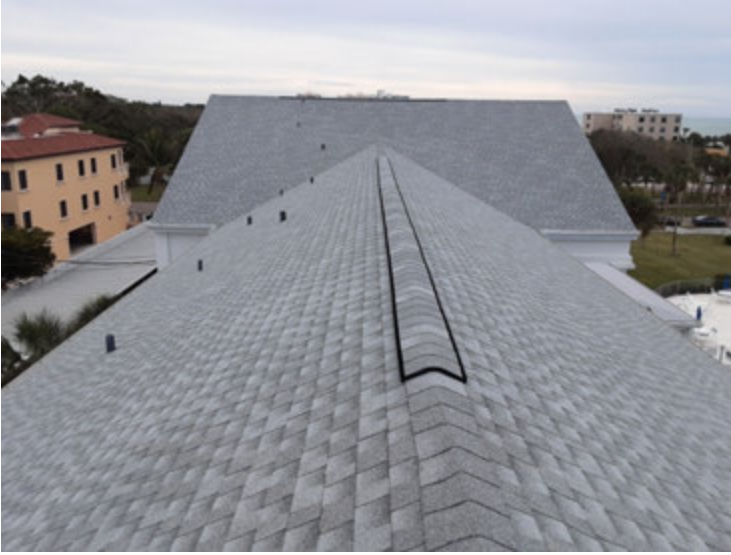
Roof Overview
General roof overview

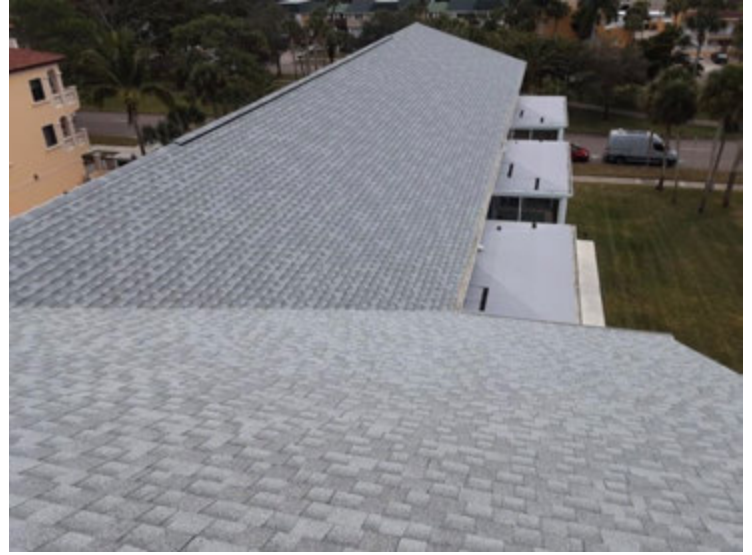
Appearance Overview
The roof appearance is in good condition.

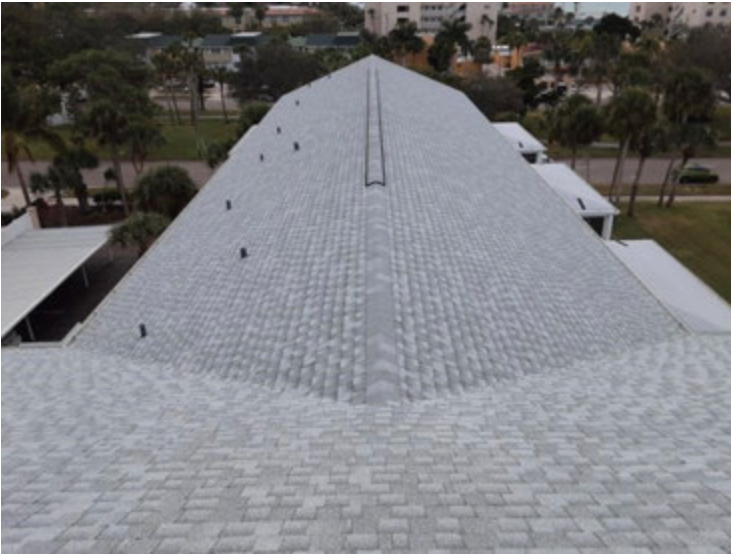
Surface Overview
The roof surface appears to be in good condition.

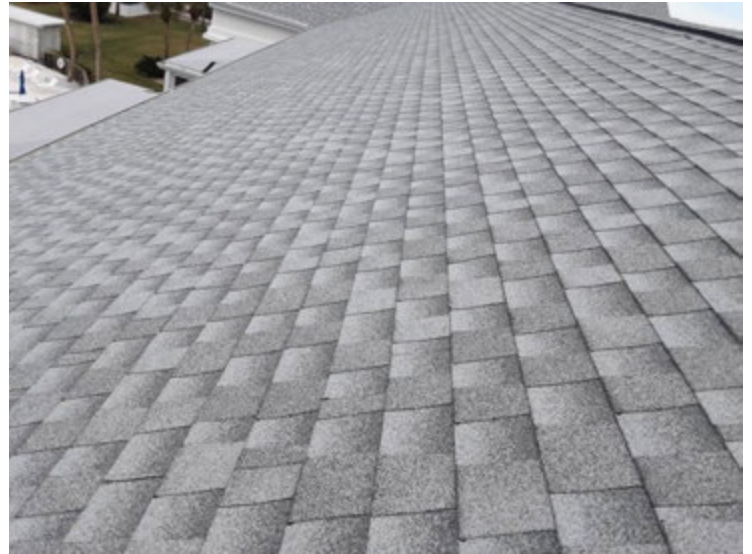
Field Shingles
Field shingles appear to be good condition.

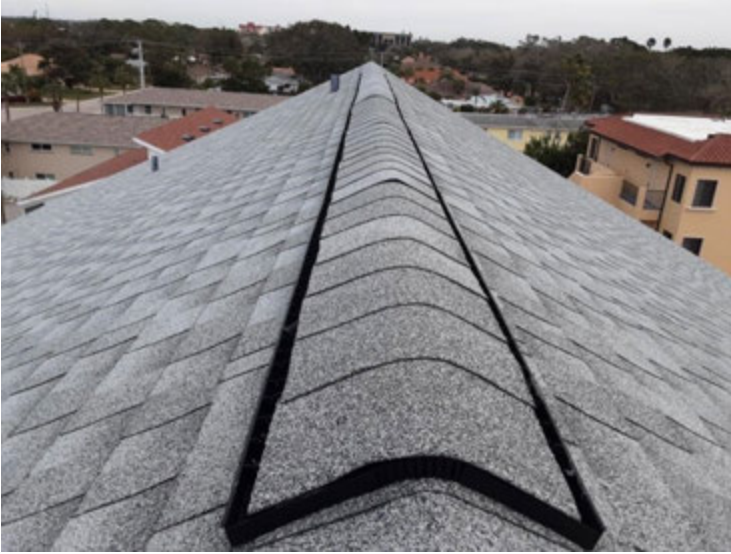
Ridge shingles appear to be in good condition.

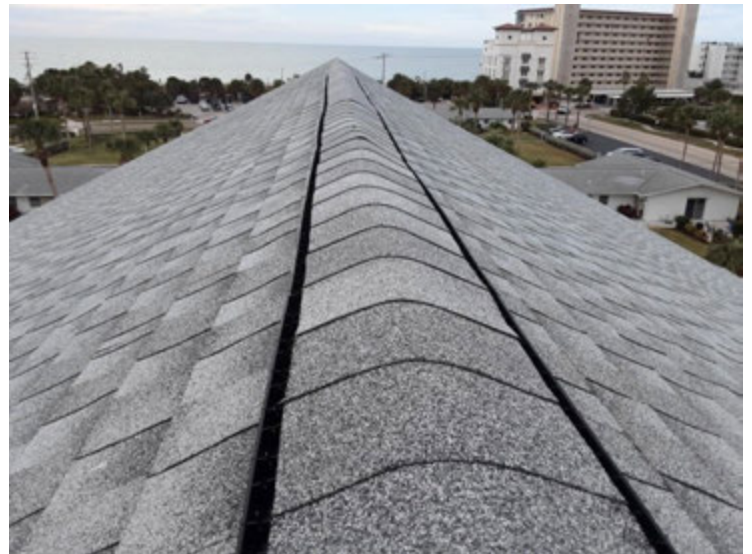
Ridge Shingles

Ridge shingles appear to be in good condition.

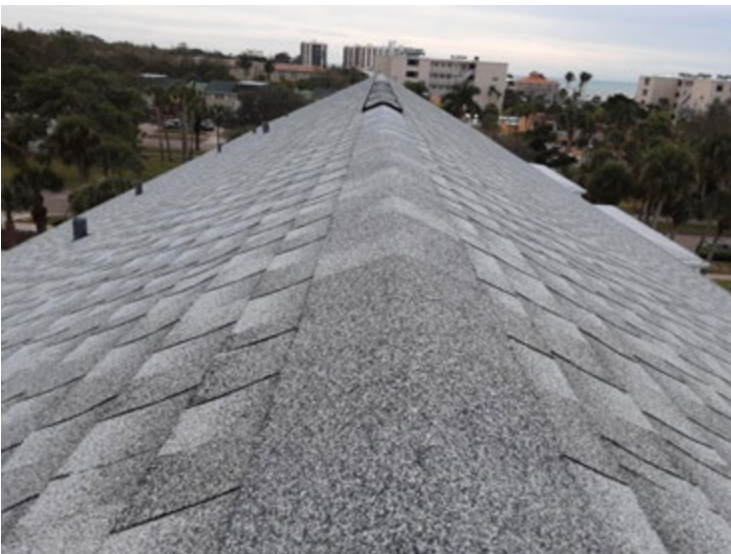
Ridge Shingles

Ridge shingles appear to be in good condition.

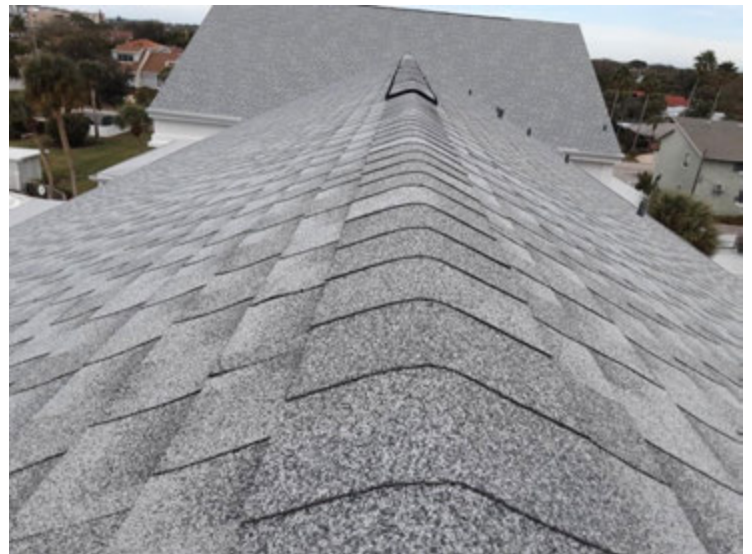
Ridge Shingles

Ridge shingles appear to be in good condition.

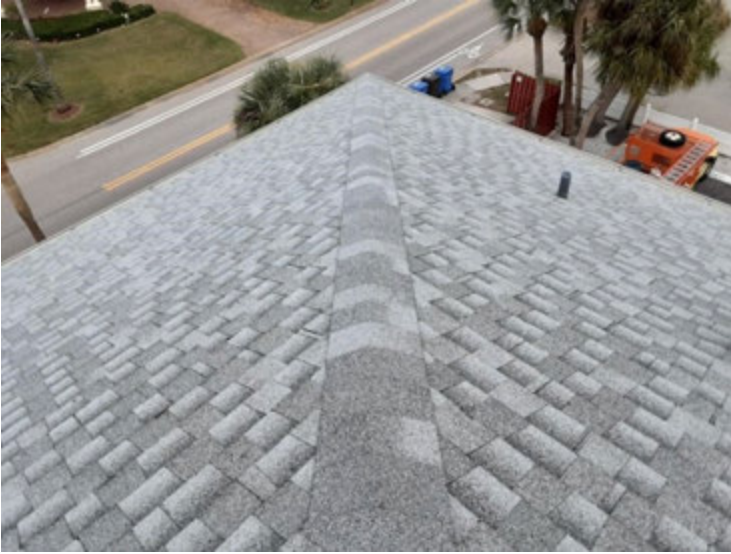
Hip Shingles

Hip shingles appear to be in good condition.

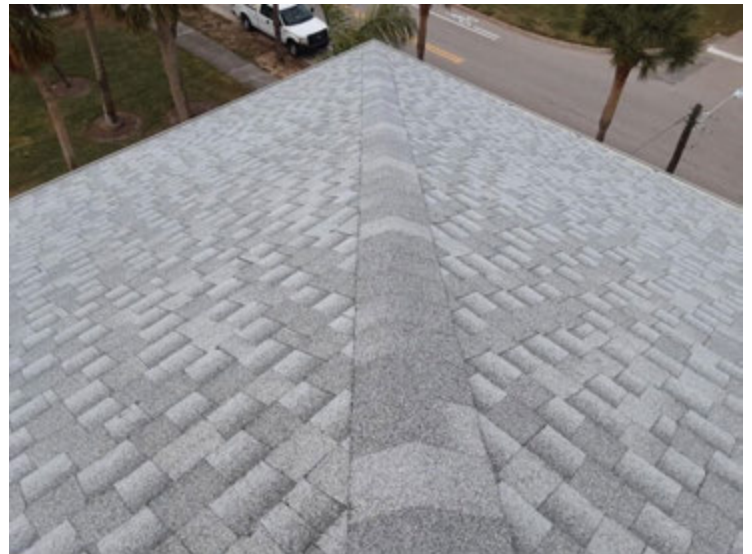
Hip Shingles

Hip shingles appear to be in good condition.

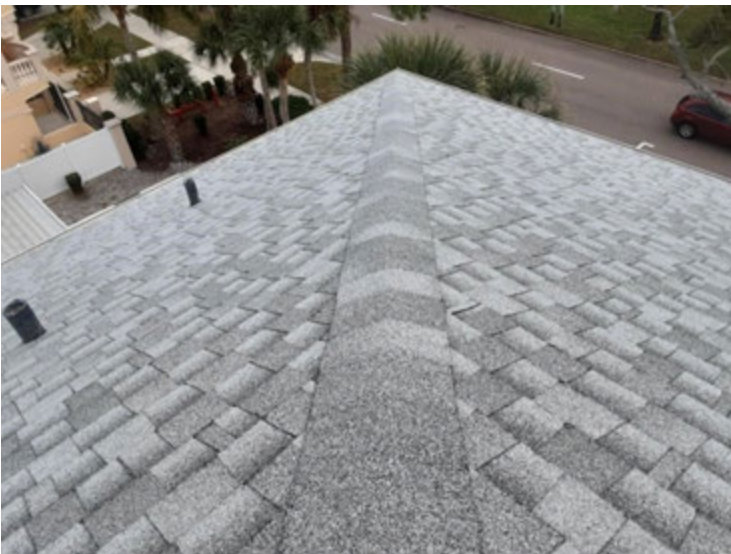
Hip Shingles

Hip shingles appear to be in good condition.

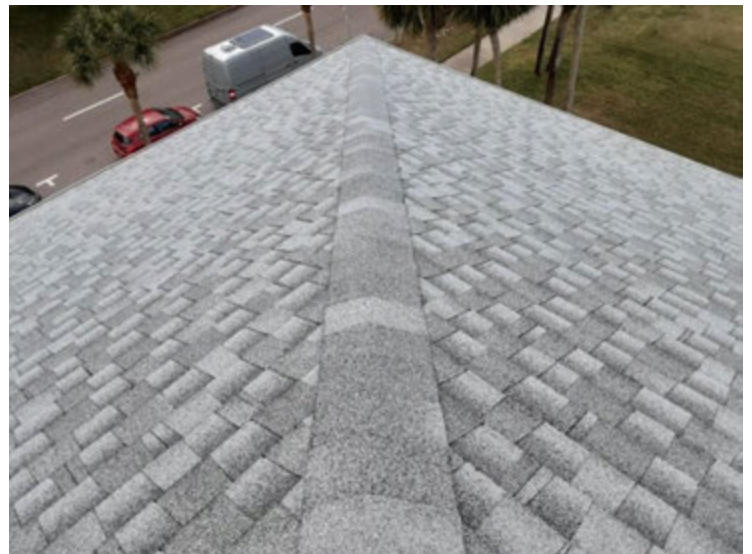
Hip Shingles

Hip shingles appear to be in good condition.

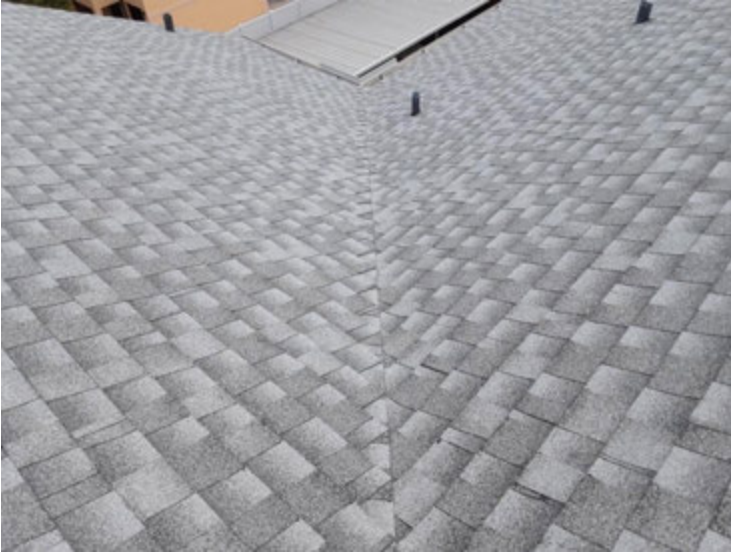
Valley Shingles

Valley shingles appear to be in good condition.

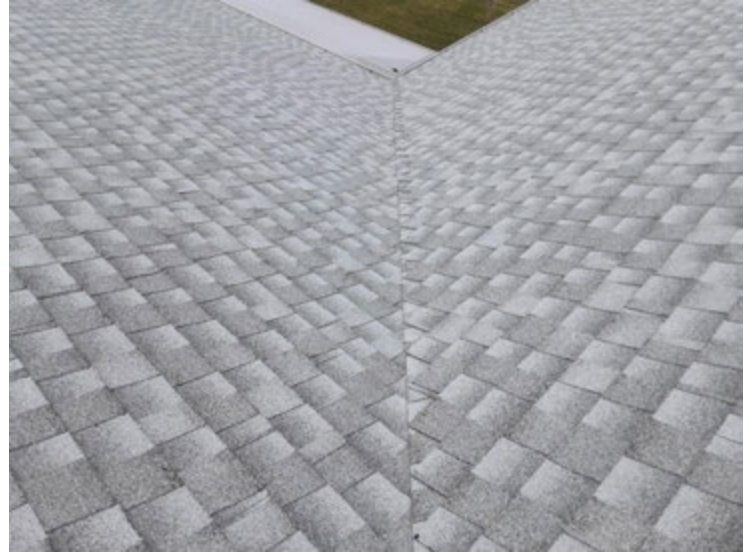
Valley Shingles

Valley shingles appear to be in good condition.

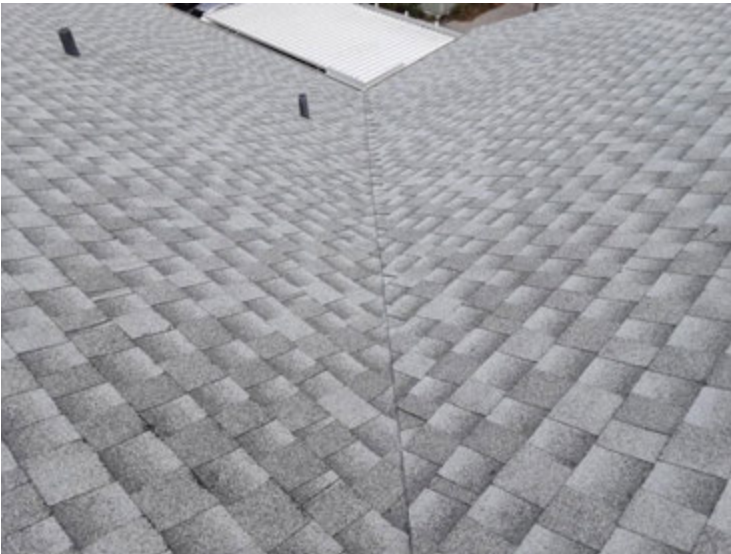
Valley Shingles

Valley shingles appear to be in good condition.

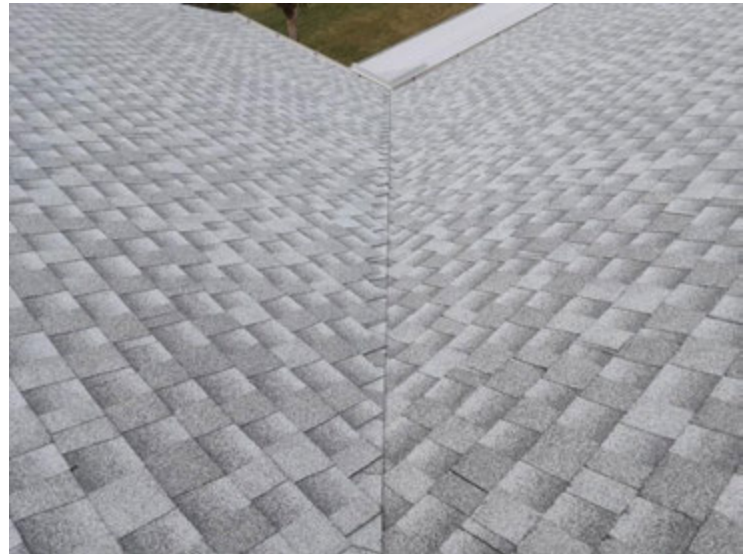
Valley Shingles

Valley shingles appear to be in good condition.

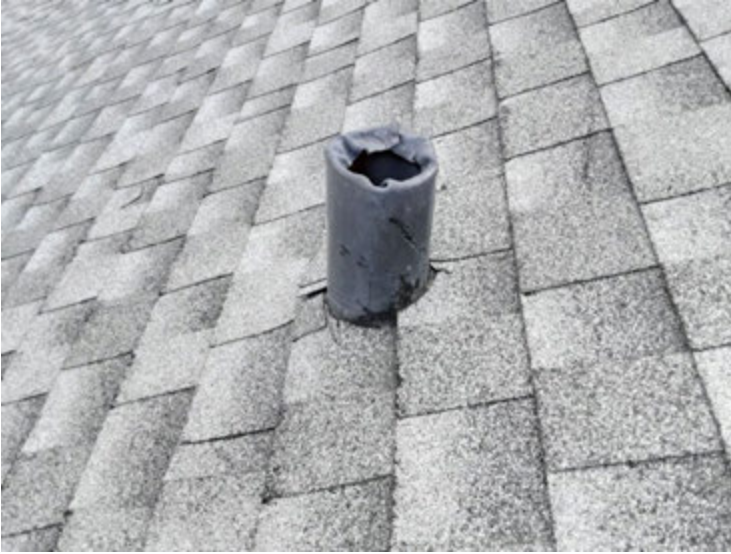
Lead Boots

Lead boots appear to be in good condition.

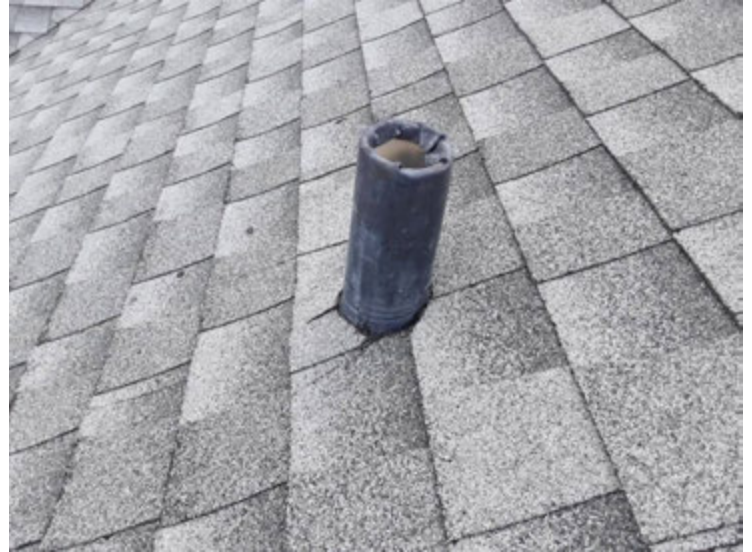
Lead Boots

Lead boots appear to be in good condition.

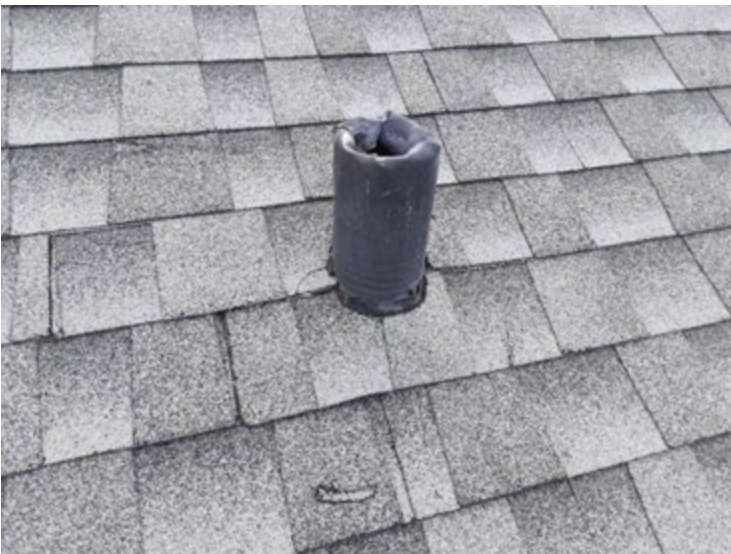
Lead Boots

Lead boots appear to be in good condition.

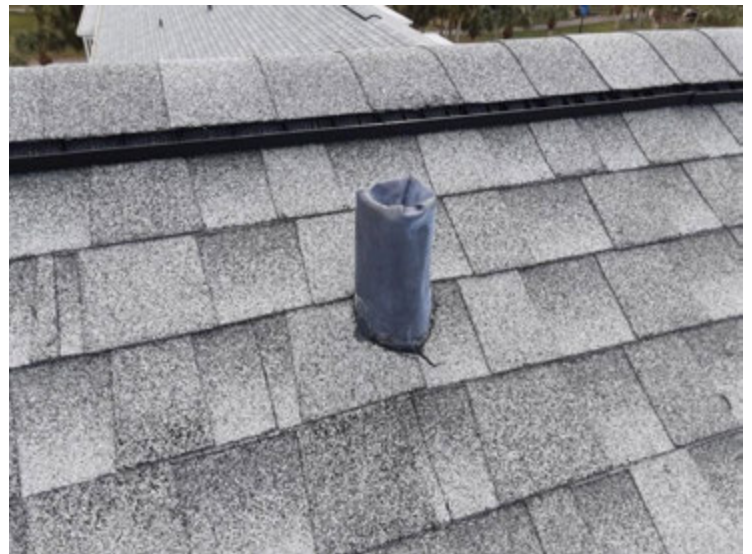
Lead Boots

Lead boots appear to be in good condition.

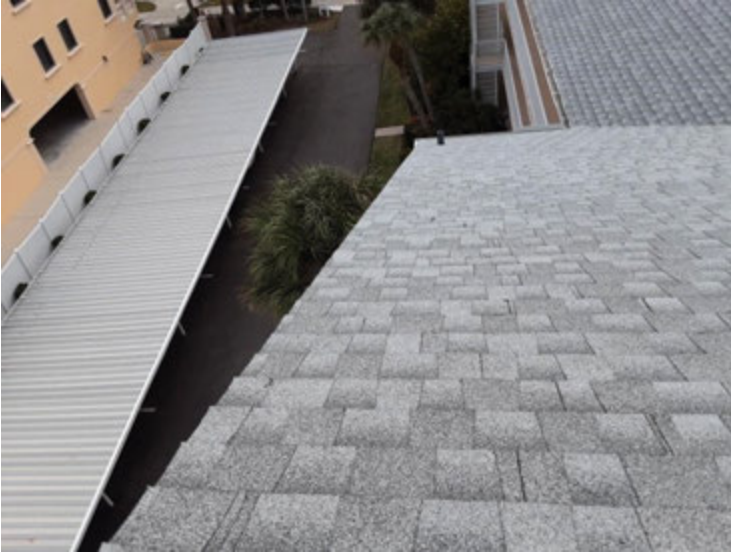
Roof Edge

Roof edge appears to be in good condition.

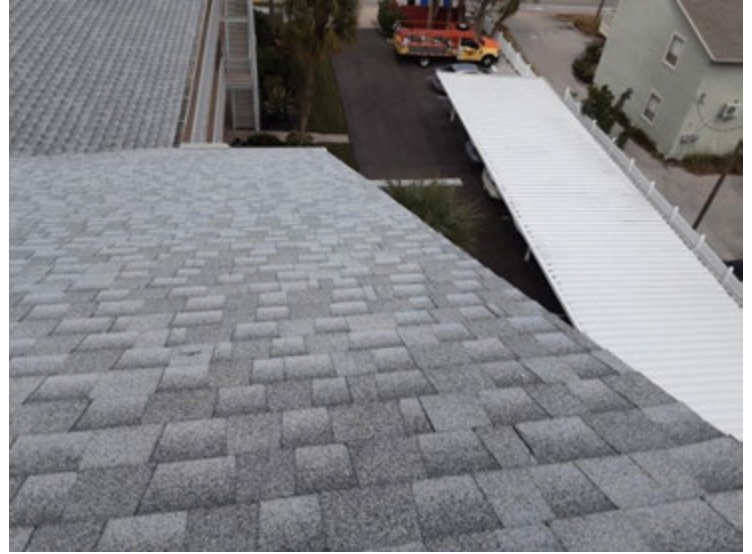
Roof Edge

Roof edge appears to be in good condition.

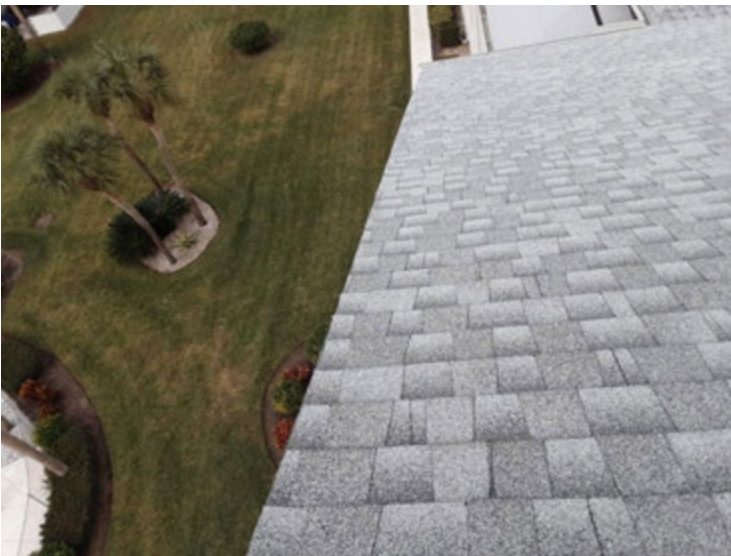
Roof Edge

Roof edge appears to be in good condition.

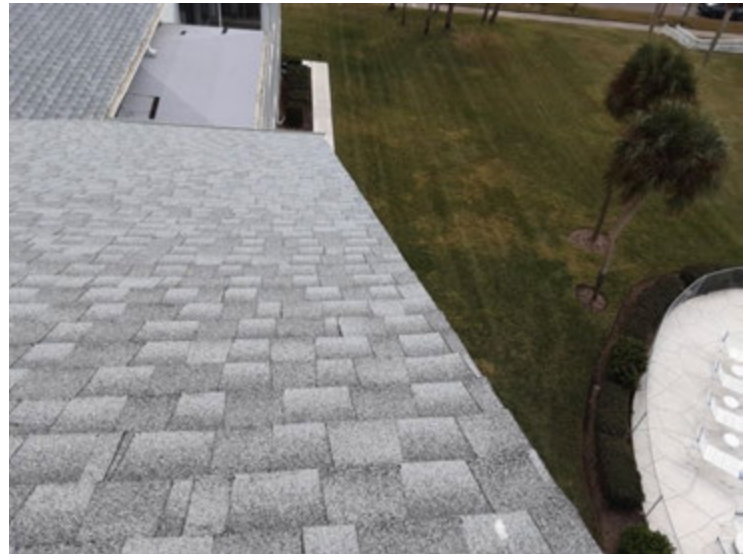
Roof Edge

Roof edge appears to be in good condition.

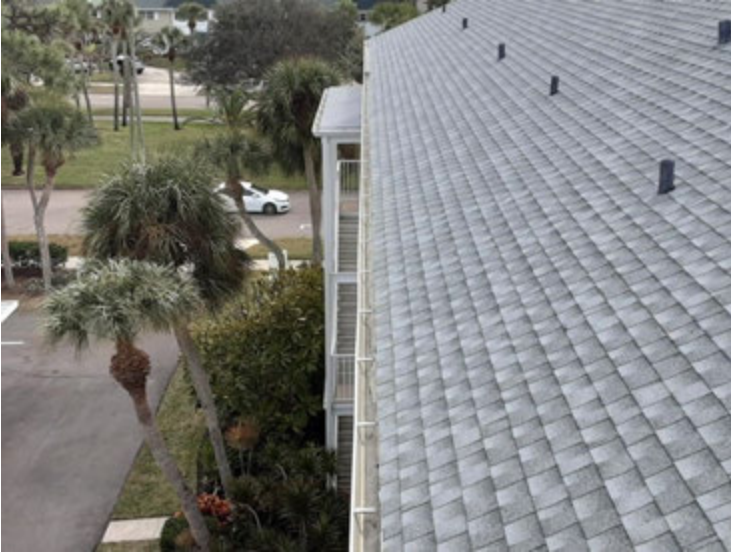
Gutters

The gutters appear to be in good condition.

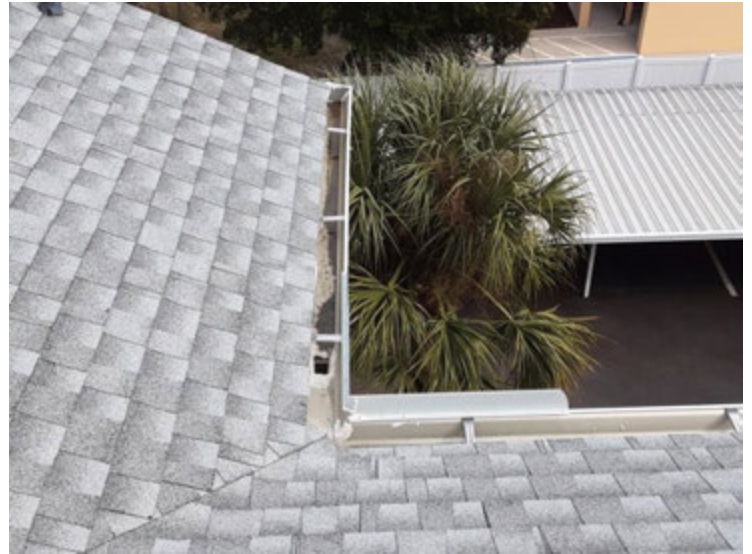
Gutters

The gutters appear to be in good condition.

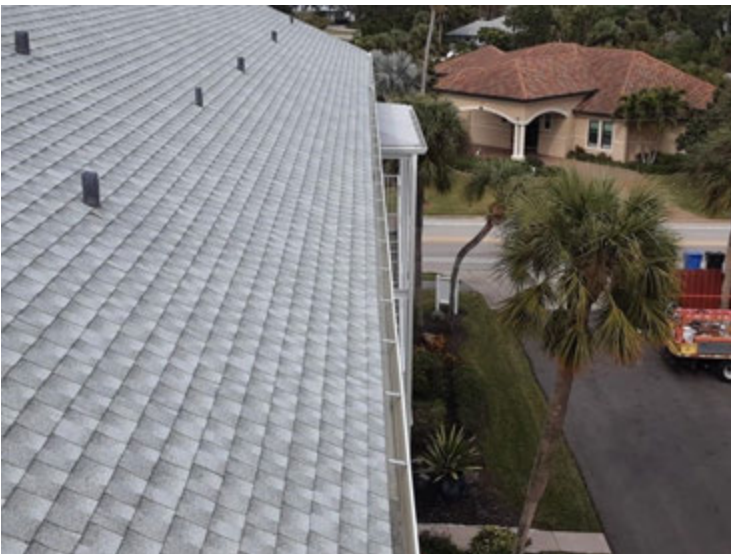
Gutters

The gutters appear to be in good condition.

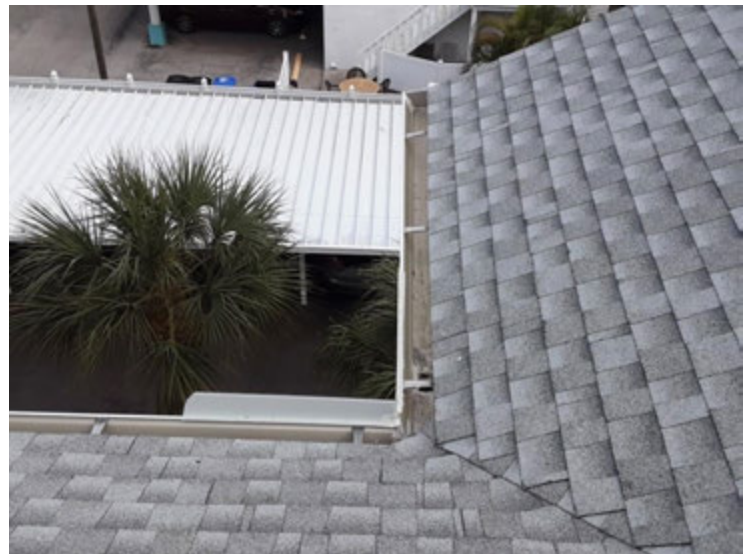
Gutters

The gutters appear to be in good condition.

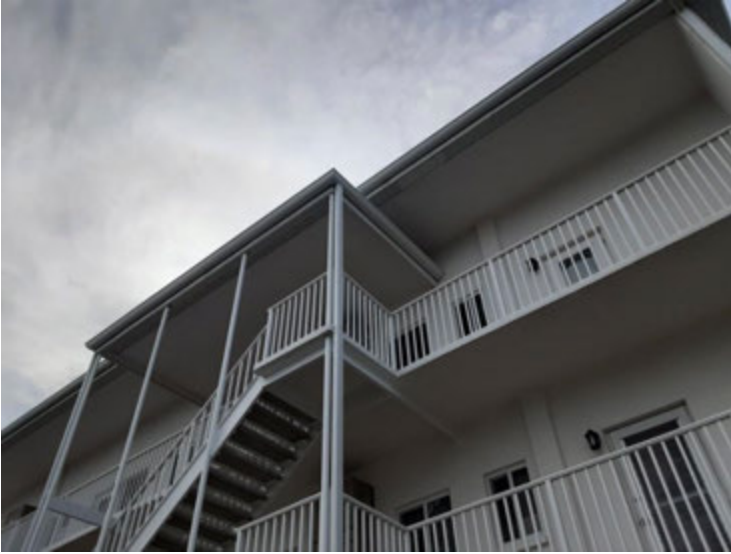
Downspouts

The downspouts appear to be in good condition.

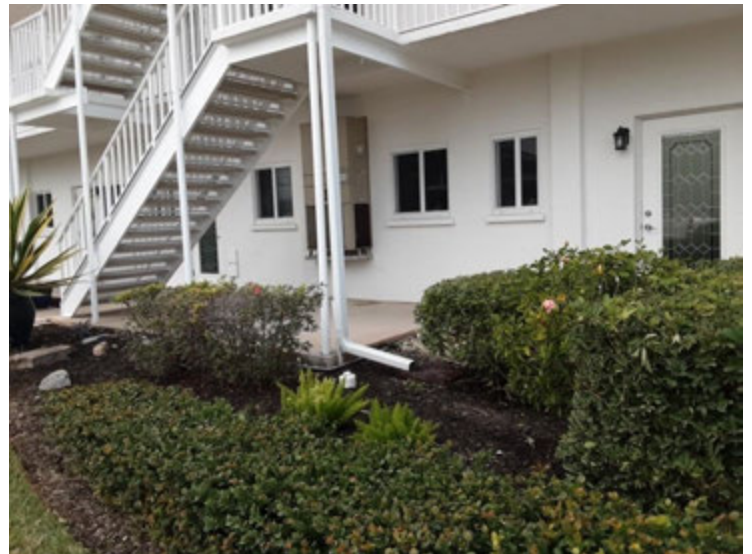
Downspouts

The downspouts appear to be in good condition.

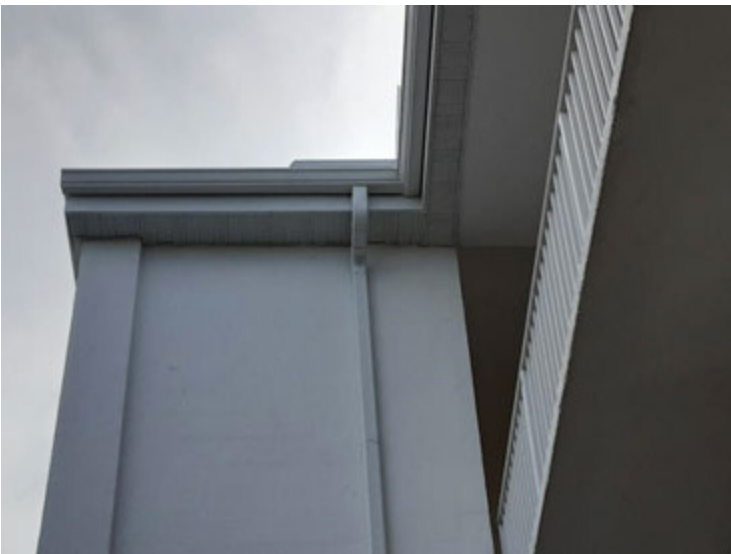
Downspouts

The downspouts appear to be in good condition.

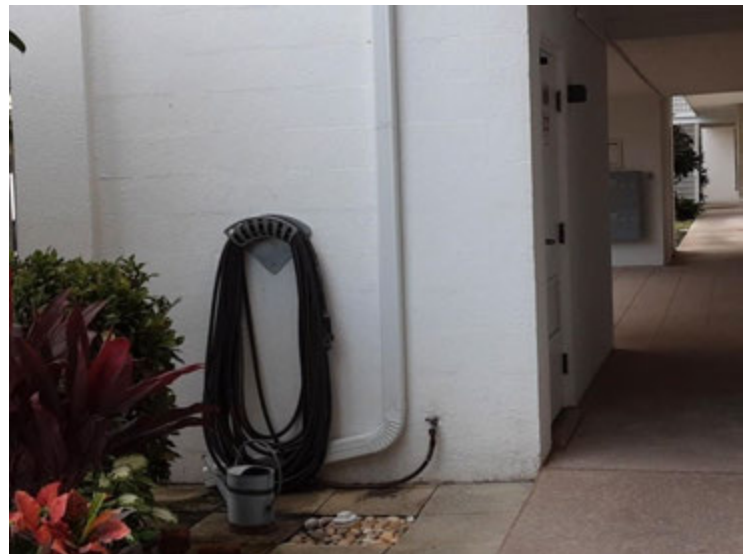
Downspouts

The downspouts appear to be in good condition.

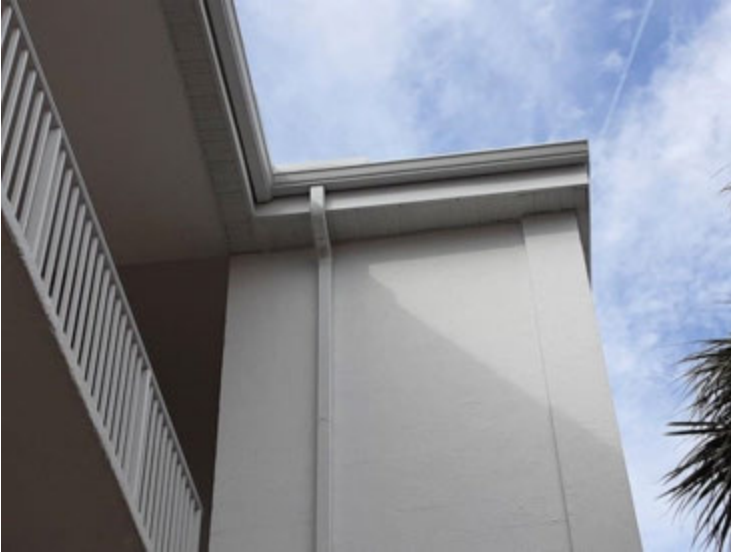
Downspouts

The downspouts appear to be in good condition.

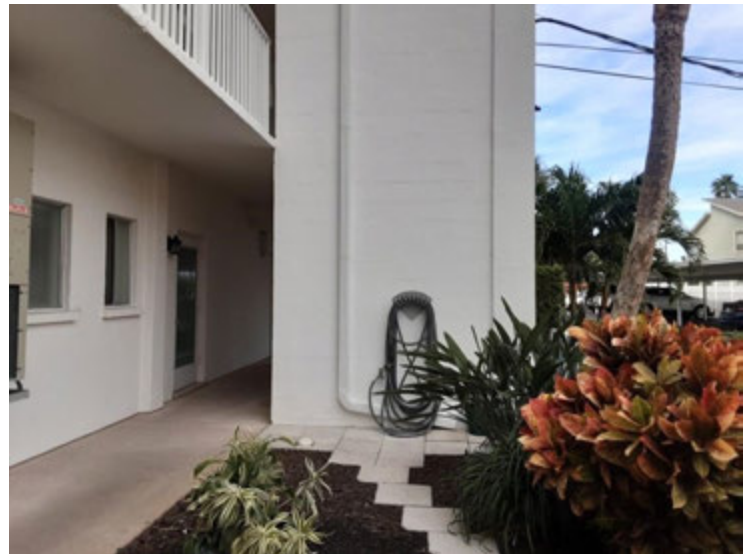
Downspouts

The downspouts appear to be in good condition.

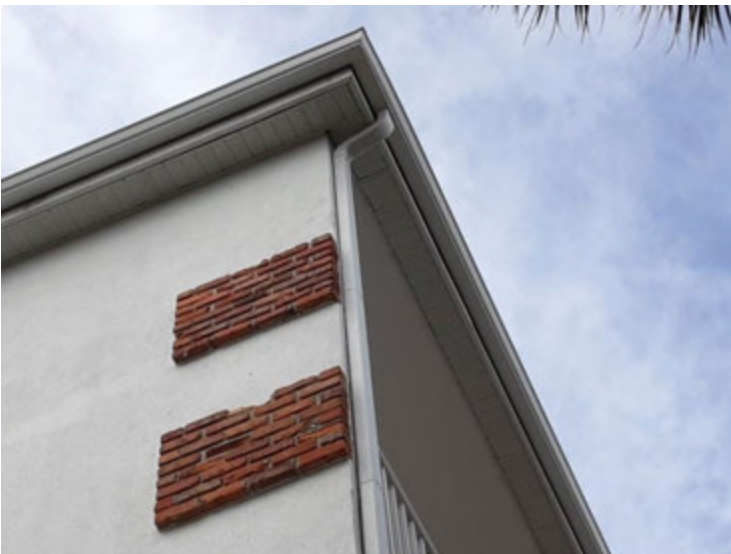
Downspouts

The downspouts appear to be in good condition.

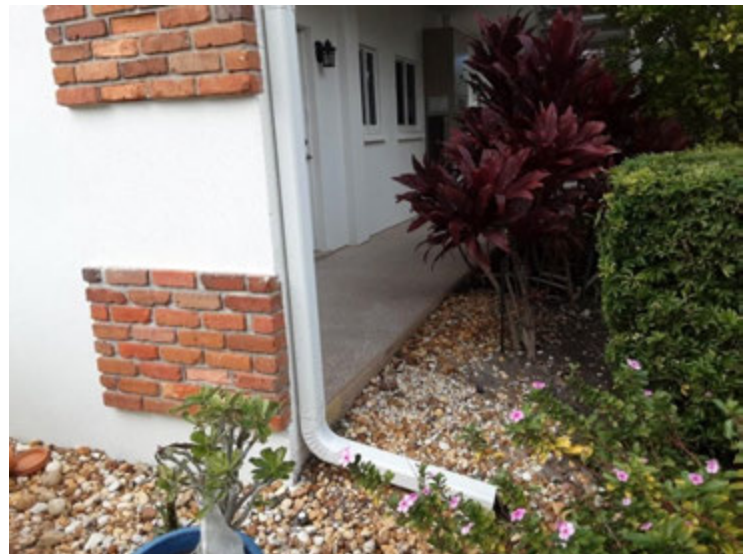
Downspouts

The downspouts appear to be in good condition.

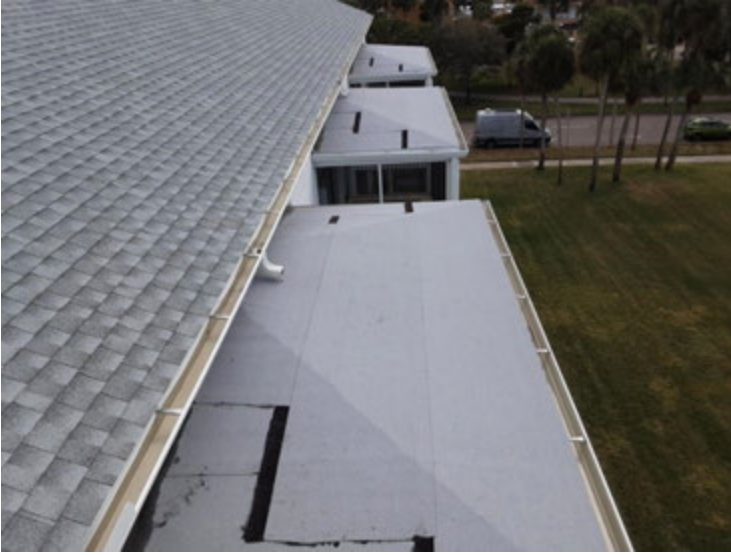
Lower Roof 1 - Appearance Overview
The appearance of the roof is in good condition.

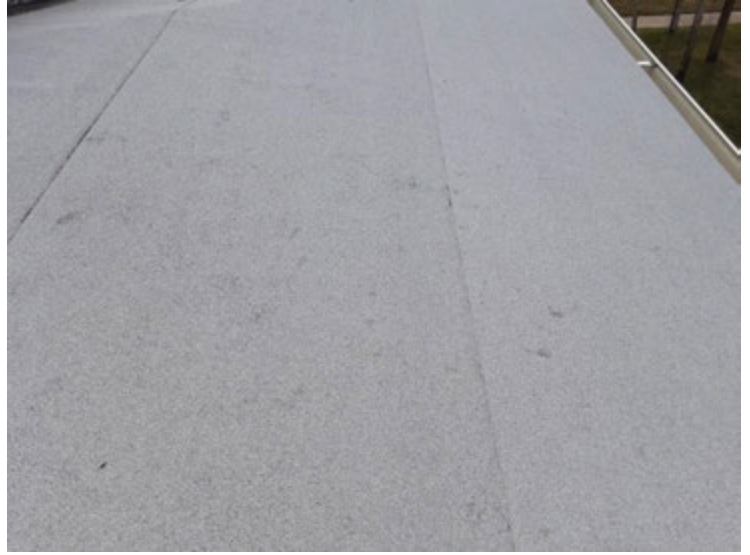
Lower Roof 1 - Membrane Overview
The membrane appears to be in good condition.

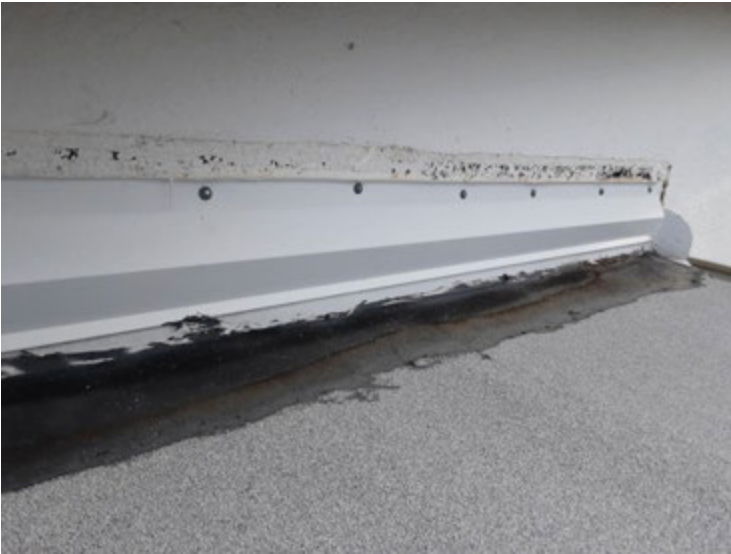
Lower Roof 1 - Counter Flashings
The counter flashing appears to be in good condition.

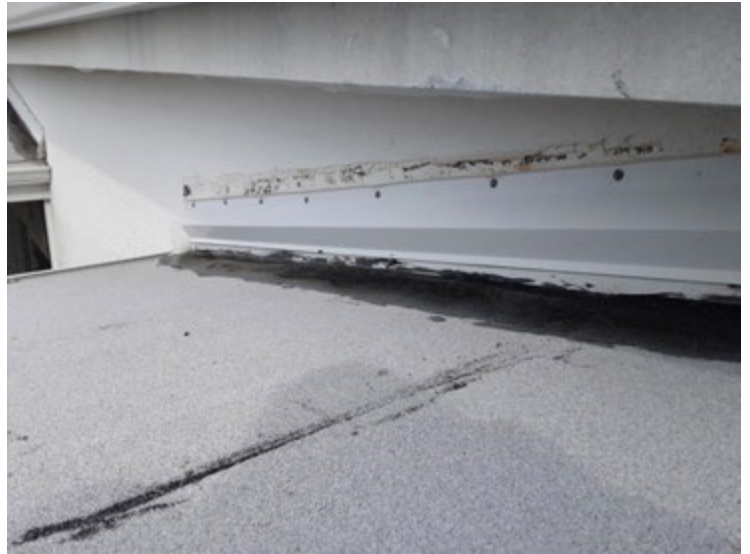
Lower Roof 1 - Counter Flashings
The counter flashing appears to be in good condition.

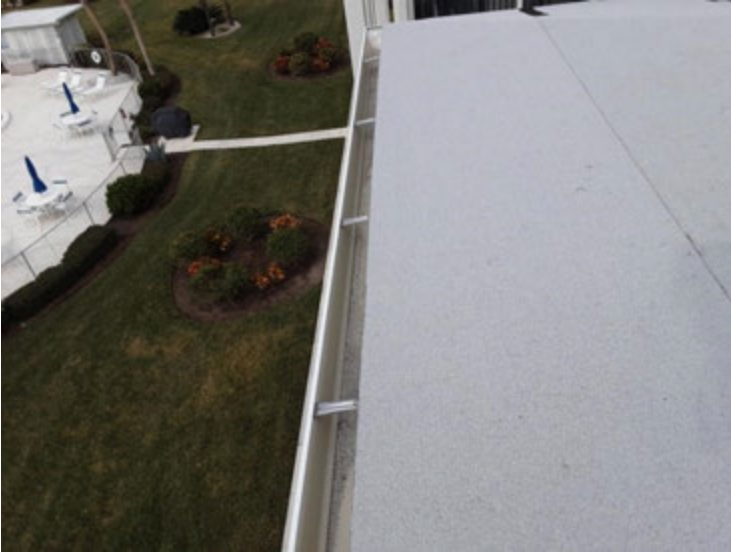
Lower Roof 1 - Gutters

The gutters appear to be in good condition.

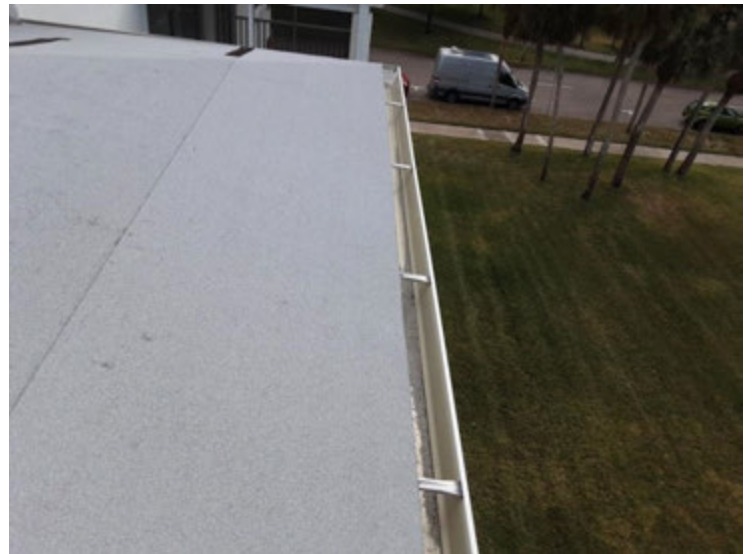
Lower Roof 1 - Gutters

The gutters appear to be in good condition.

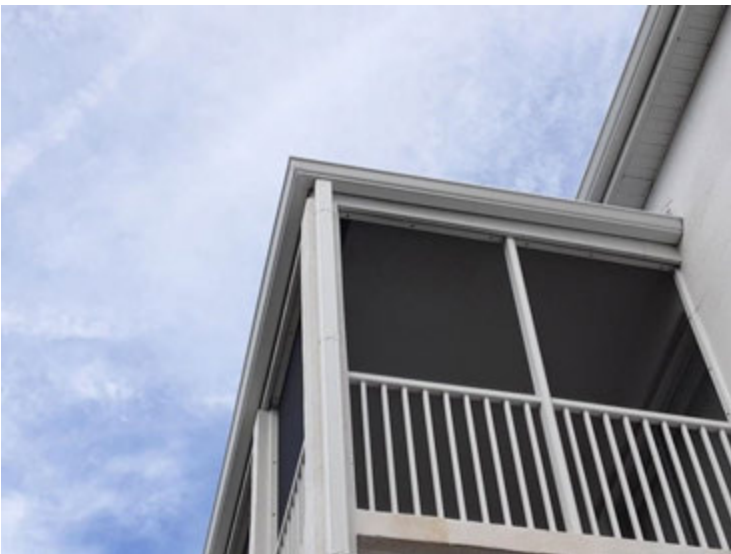
Lower Roof 1 - Downspouts

The downspouts appear to be in good condition.

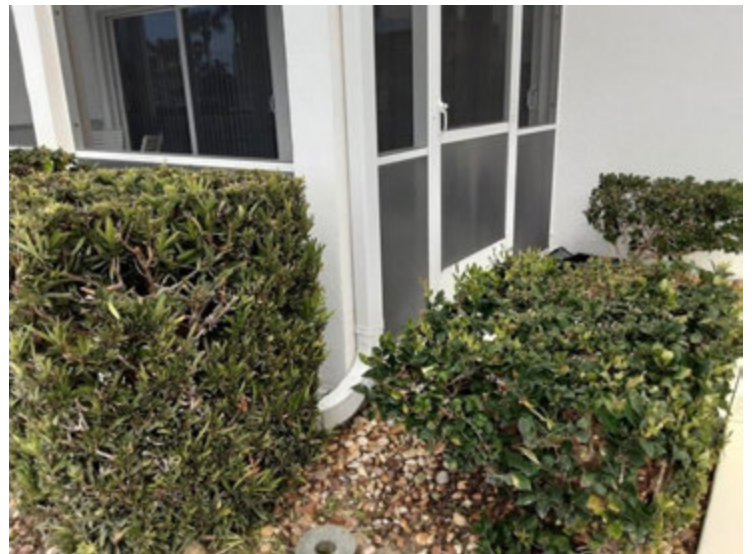
Lower Roof 1 - Downspouts

The downspouts appear to be in good condition.

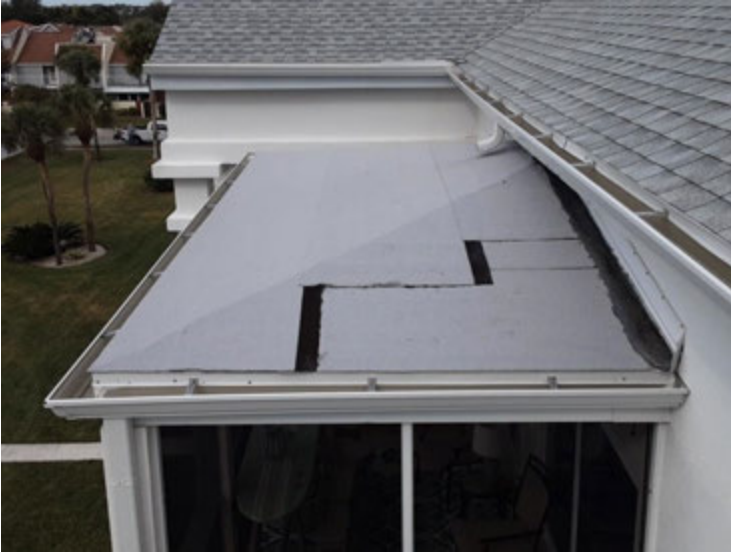
Lower Roof 2 - Appearance Overview
The appearance of the roof is in good condition.

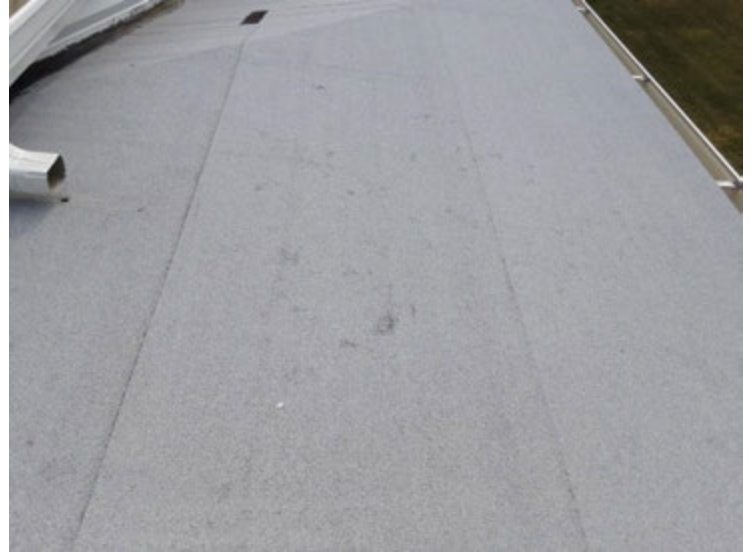
Lower Roof 2 - Membrane Overview
The membrane appears to be in good condition.

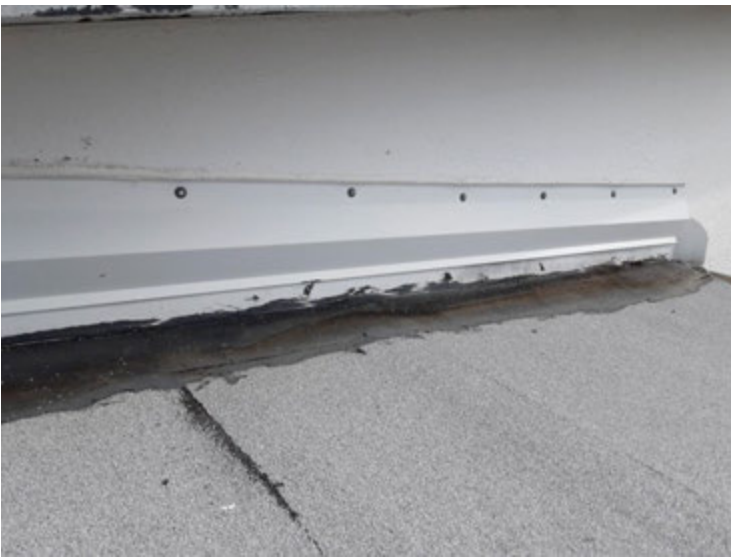
Lower Roof 2 - Counter Flashings
The counter flashing appears to be in good condition.

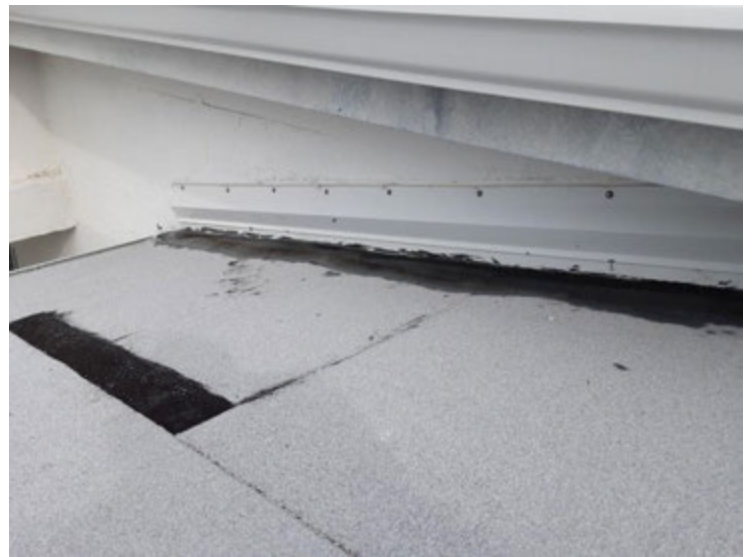
Lower Roof 2 - Counter Flashings
The counter flashing appears to be in good condition.

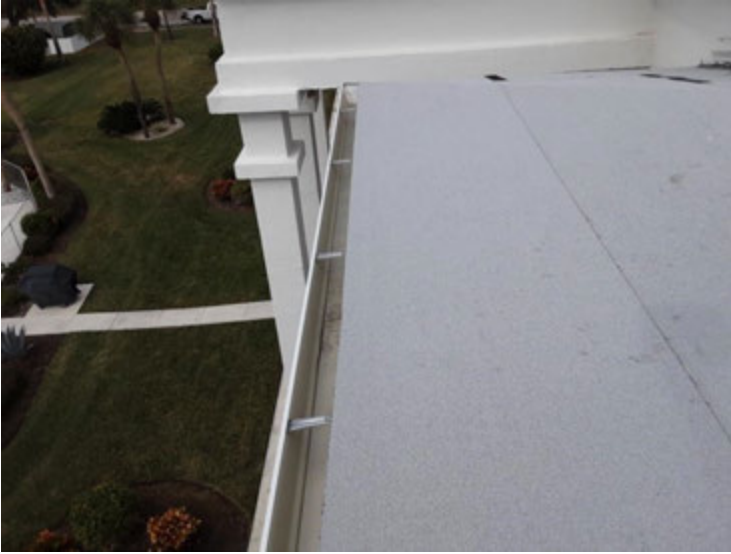
Lower Roof 2 - Gutters

The gutters appear to be in good condition.

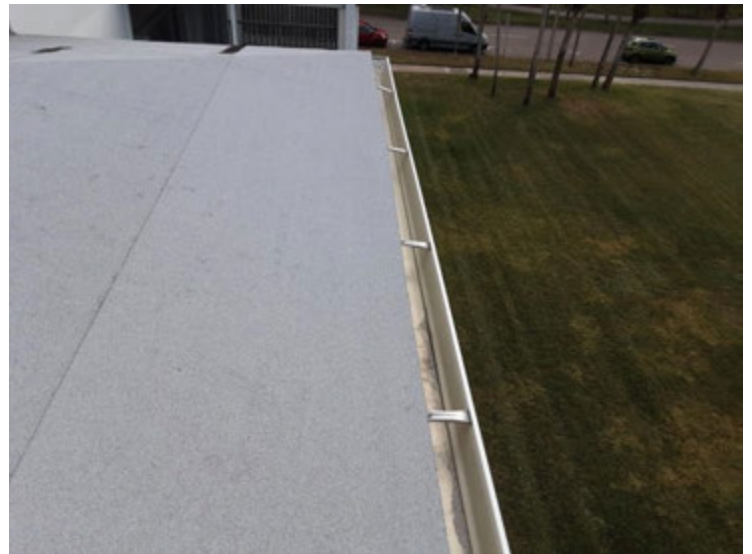
Lower Roof 2 - Gutters

The gutters appear to be in good condition.

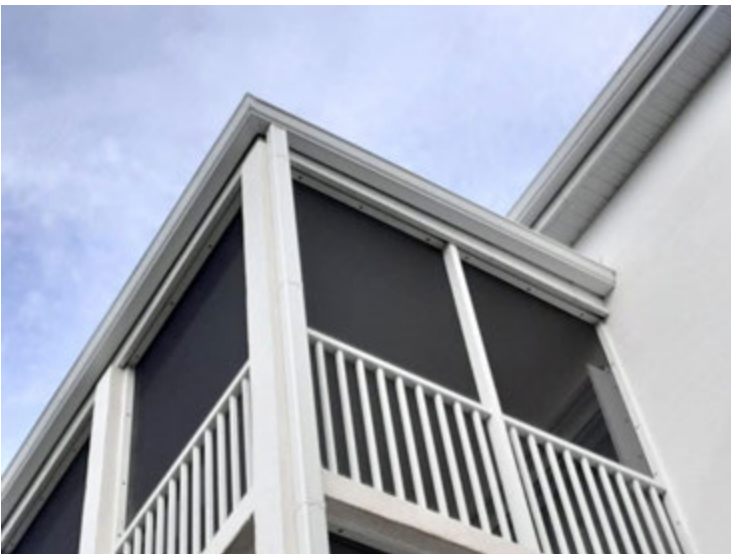
Lower Roof 2 - Downspouts

The downspouts appear to be in good condition.

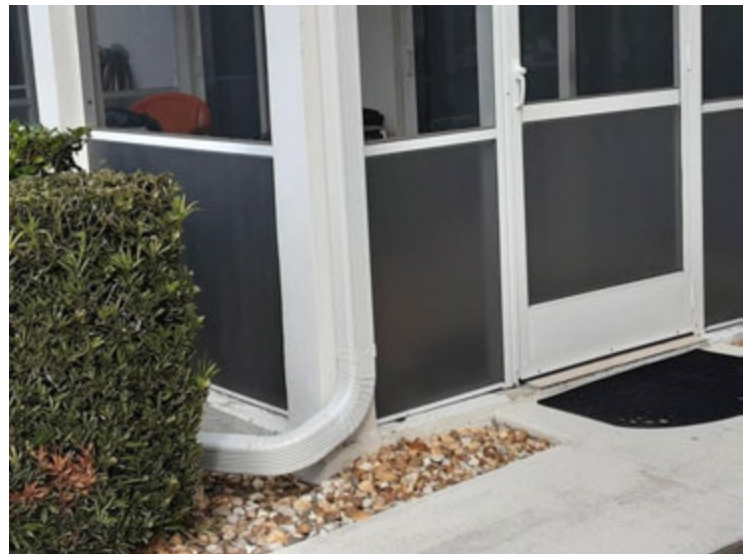
Lower Roof 2 - Downspouts

The downspouts appear to be in good condition.

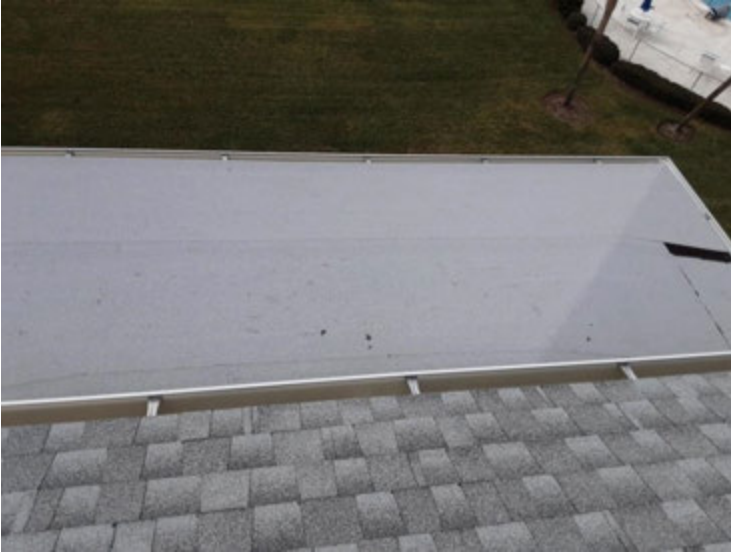
Lower Roof 3 - Appearance Overview
The appearance of the roof is in good condition.

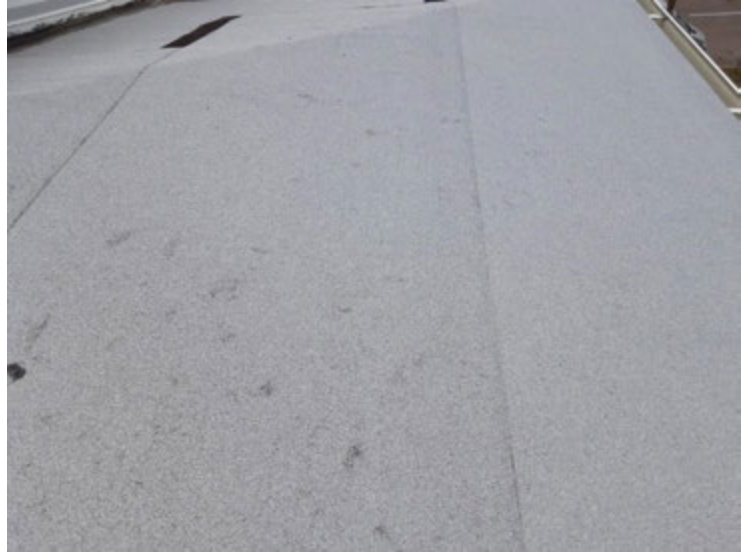
Lower Roof 3 - Membrane Overview
The membrane appears to be in good condition.
