Inspection Report

Facility: Venice Beach Apartments II

Venice Beach Apartments II, Venice, FL

Re: Inspection Report (3 of 6) for Venice Beach Apartments II performed 01/03/2024.

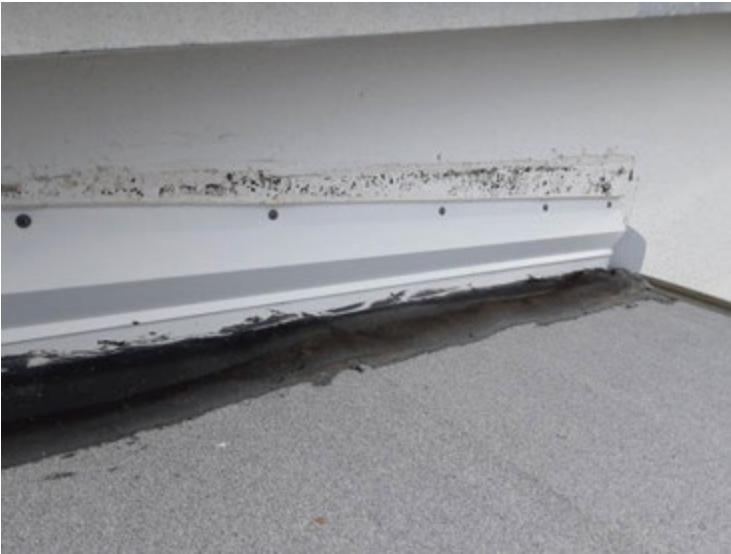
Lower Roof 3 - Counter Flashings
The counter flashing appears to be in good condition.

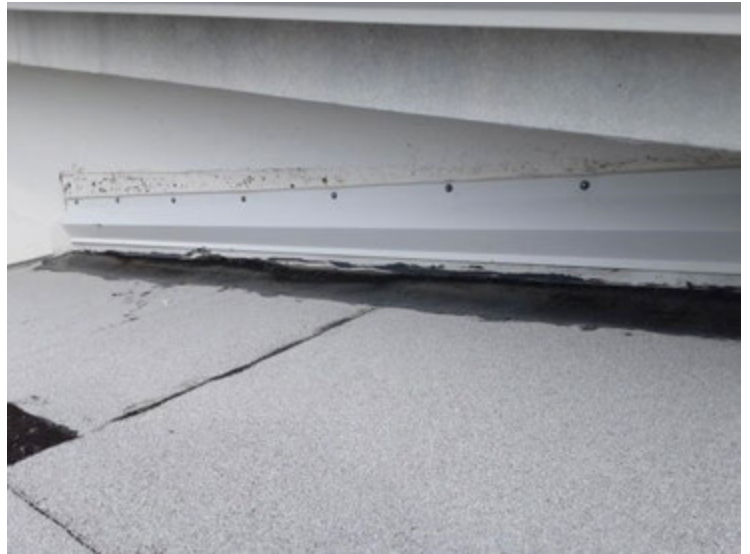
Lower Roof 3 - Counter Flashings
The counter flashing appears to be in good condition.

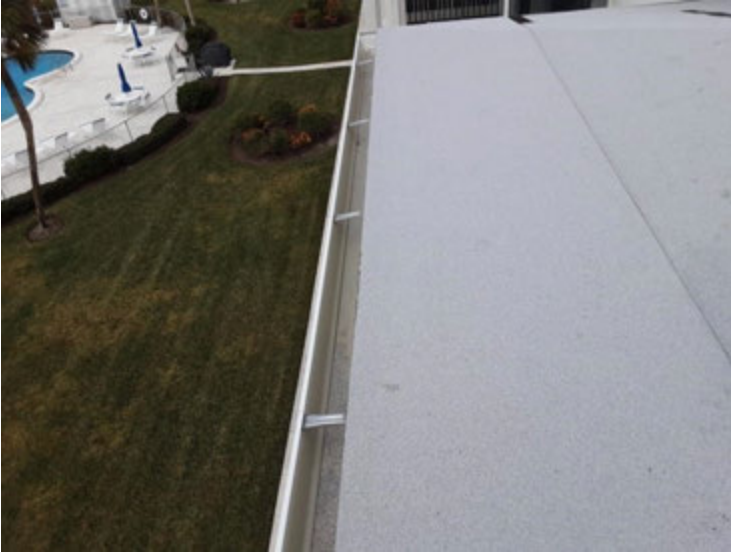
Lower Roof 3 - Gutters

The gutters appear to be in good condition.

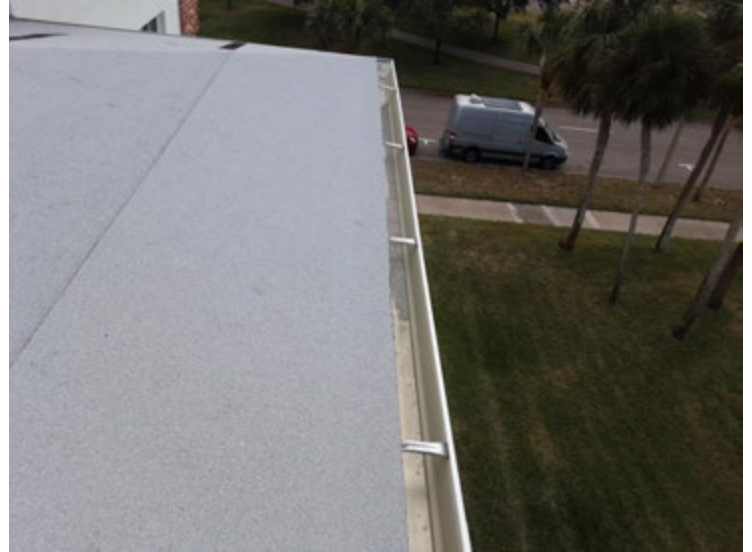
Lower Roof 3 - Gutters

The gutters appear to be in good condition.

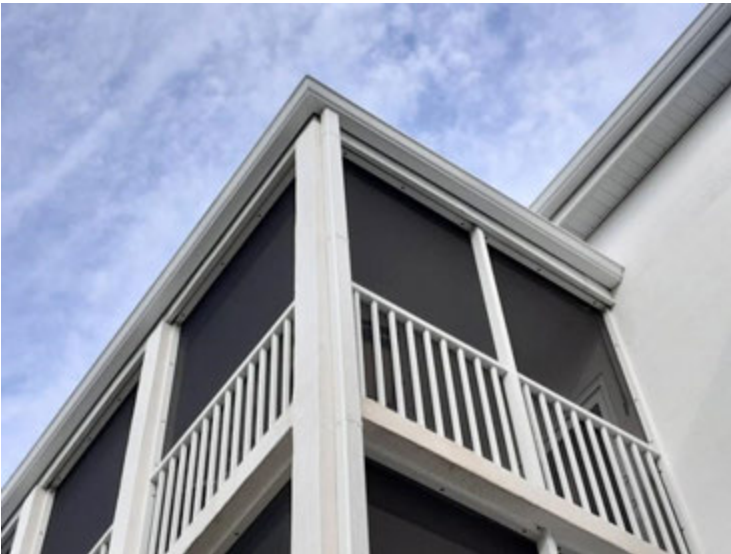
Lower Roof 3 - Downspouts

The downspouts appear to be in good condition.

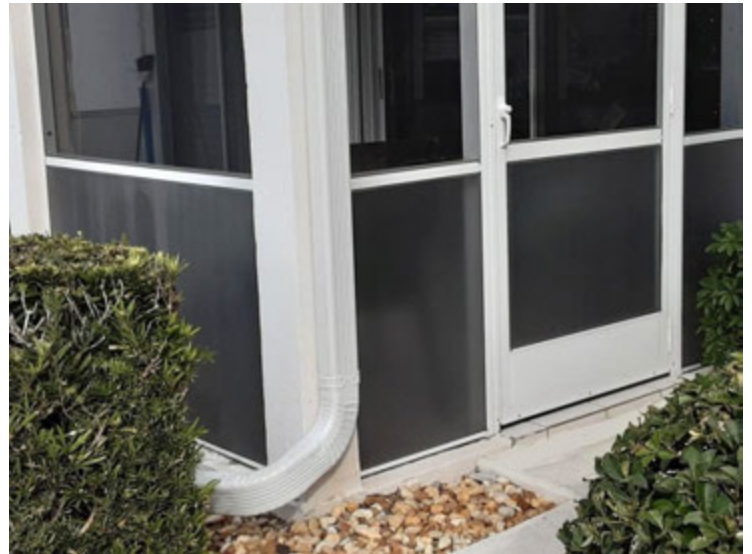
Lower Roof 3 - Downspouts

The downspouts appear to be in good condition.

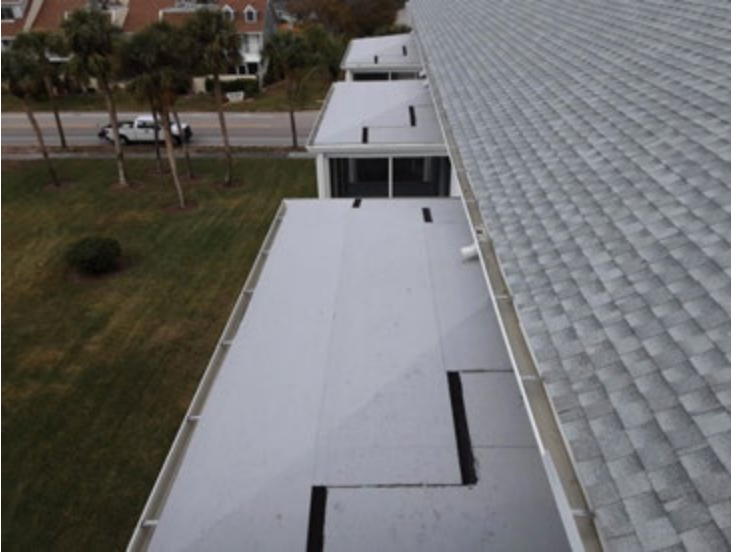
Lower Roof 4 - Appearance Overview
The appearance of the roof is in good condition.

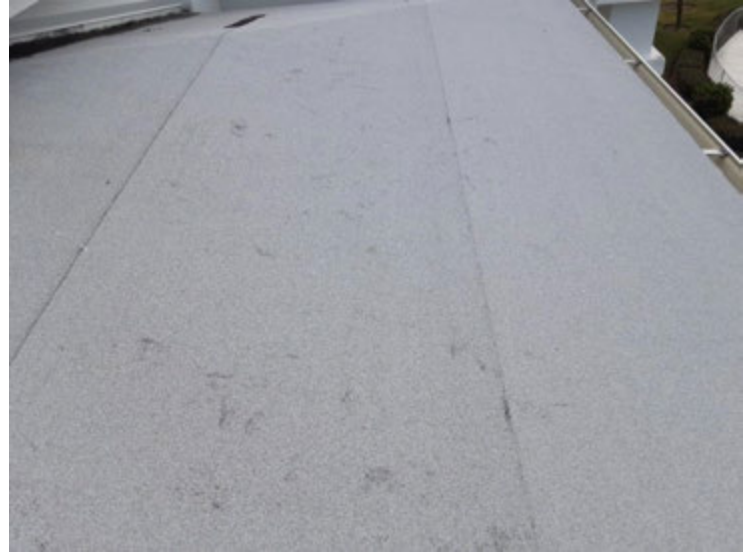
Lower Roof 4 - Membrane Overview
The membrane appears to be in good condition.

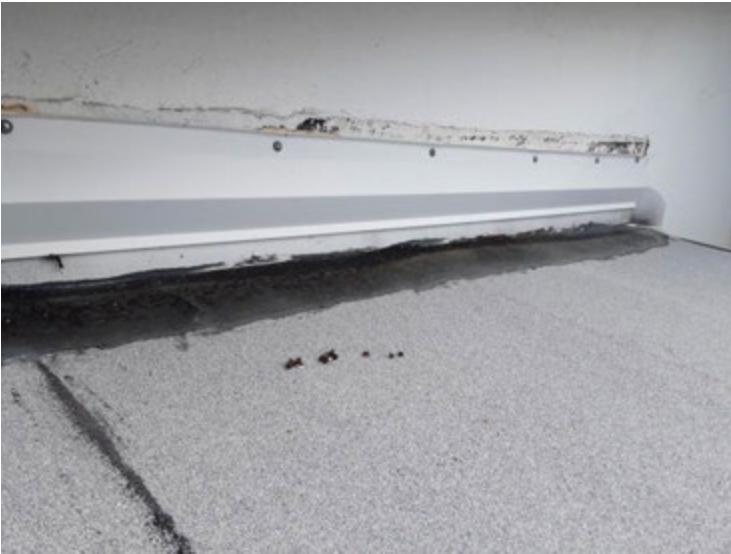
Lower Roof 4 - Counter Flashings
The counter flashing appears to be in good condition.

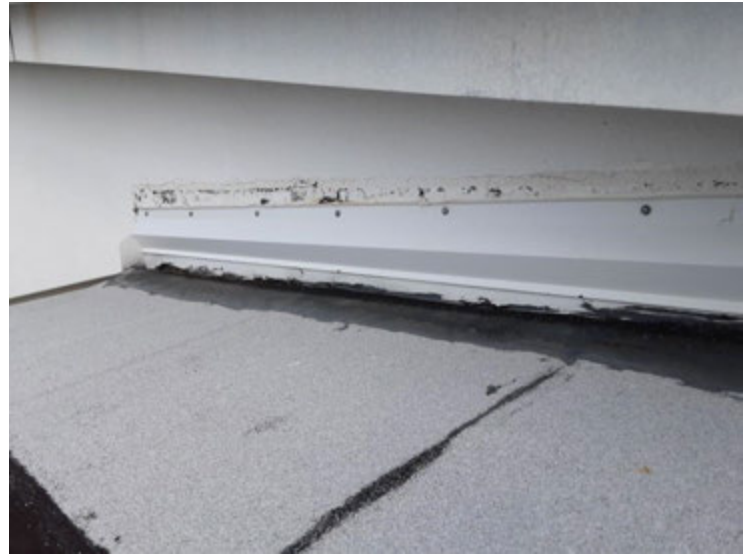
Lower Roof 4 - Counter Flashings
The counter flashing appears to be in good condition.

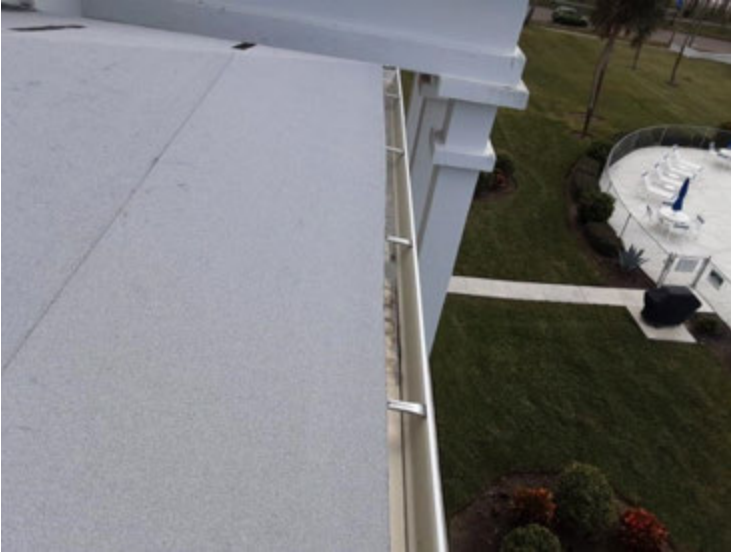
Lower Roof 4 - Gutters

The gutters appear to be in good condition.

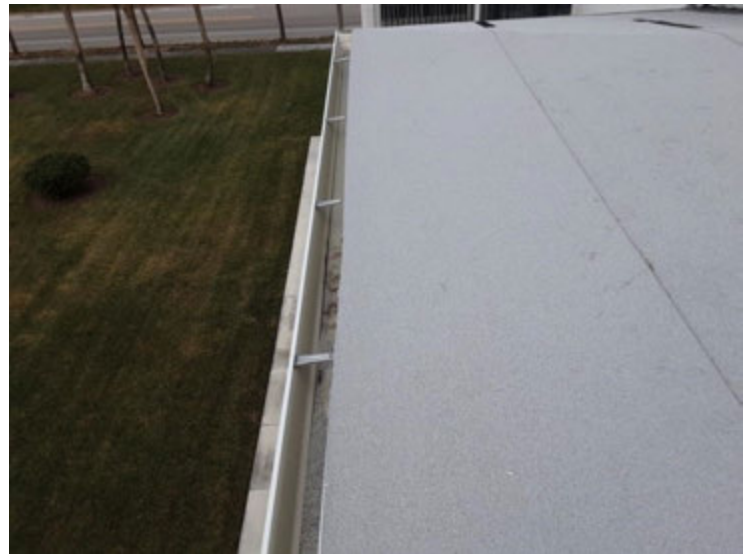
Lower Roof 4 - Gutters

The gutters appear to be in good condition.

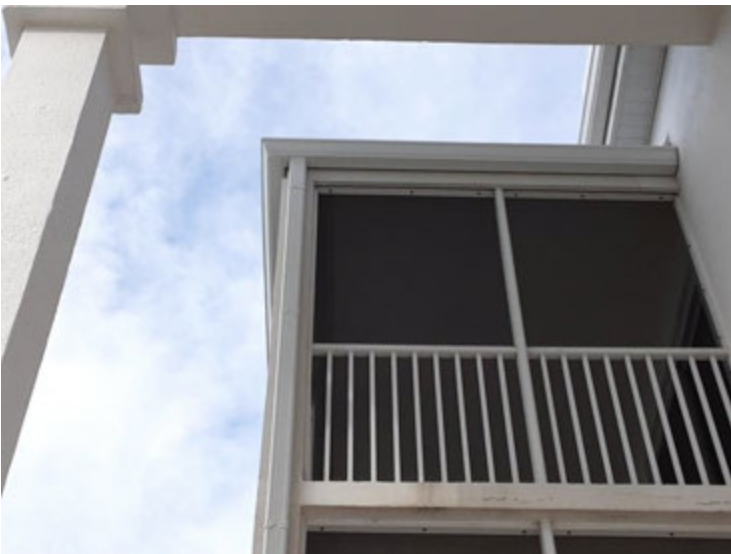
Lower Roof 4 - Downspouts

The downspouts appear to be in good condition.

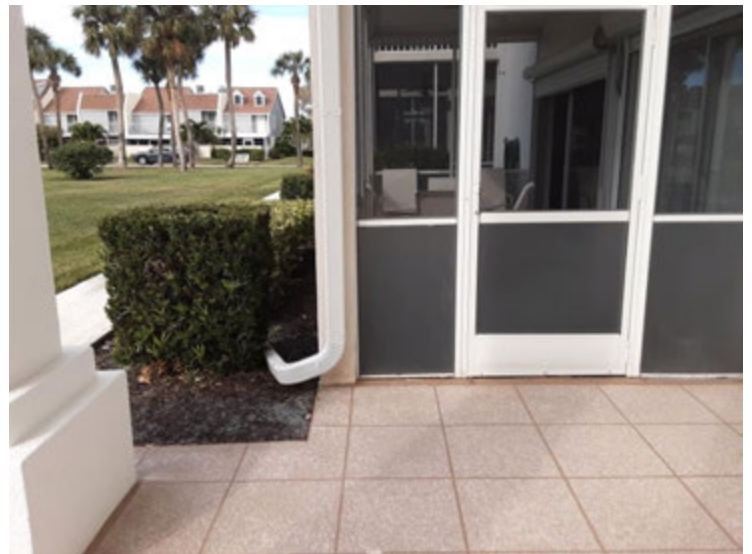
Lower Roof 4 - Downspouts

The downspouts appear to be in good condition.
